**SOUHEGAN RIVER WATERSHED
DAM NO. 14**

**NH 00433
NHWRB 175.01**

**PHASE I INSPECTION REPORT
NATIONAL DAM INSPECTION PROGRAM**

Identification No.: NH 00433
NHWRB No.: 175.01
Name of Dam: SOUHEGAN RIVER WATERSHED DAM NO. 14
Town: New Ipswich
County and State: Hillsborough County, New Hampshire
Stream: Furnace Brook, Tributary of Souhegan River
Date of Inspection: April 30, 1979

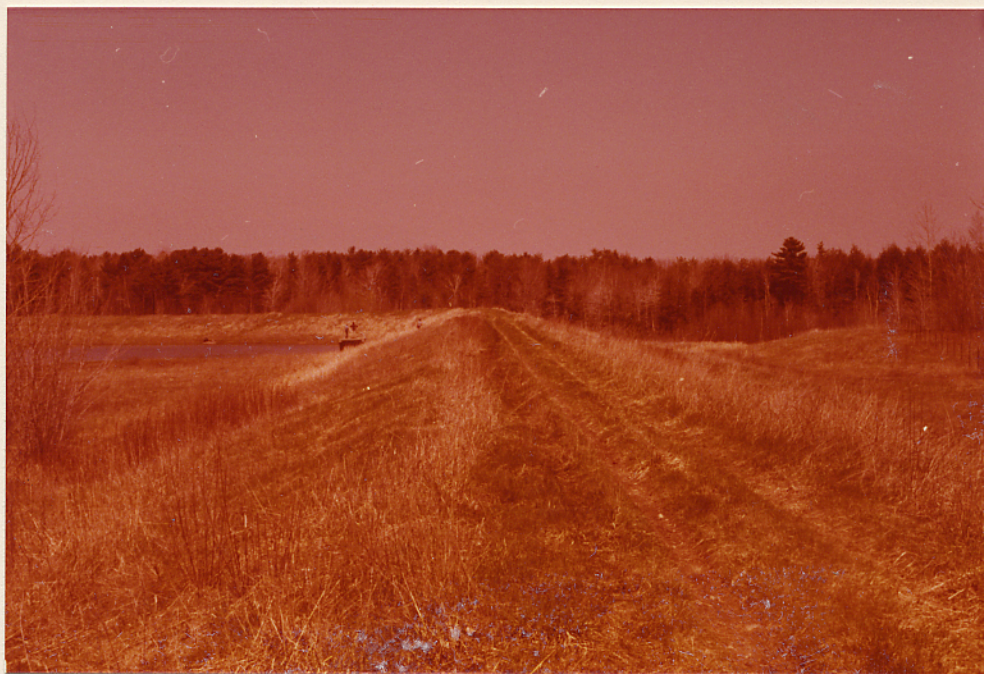
Overview from right abutment

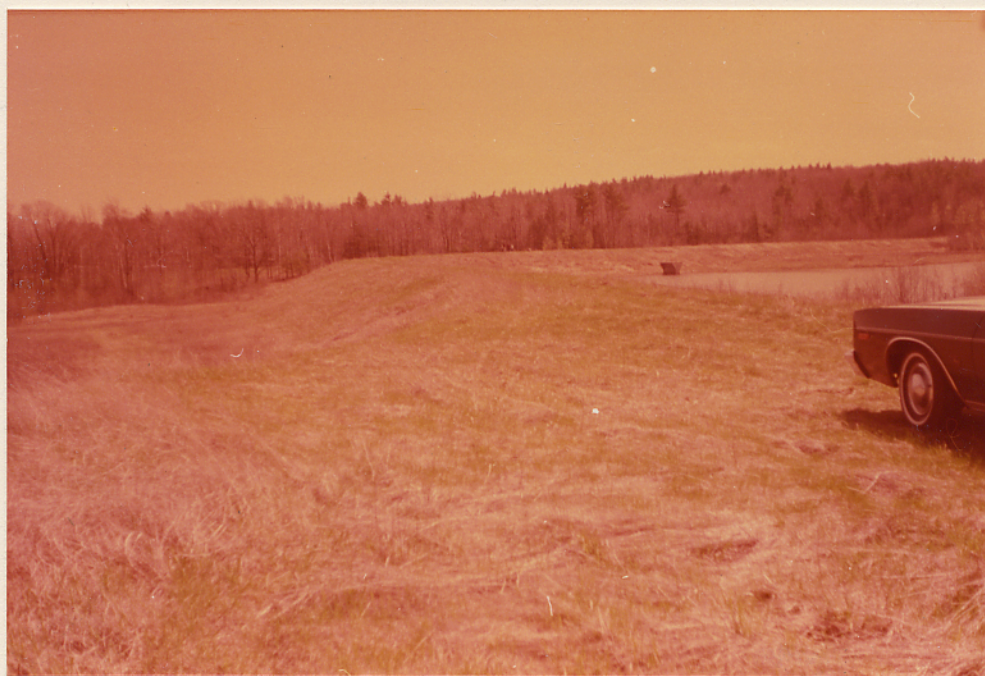
Overview from left abutment

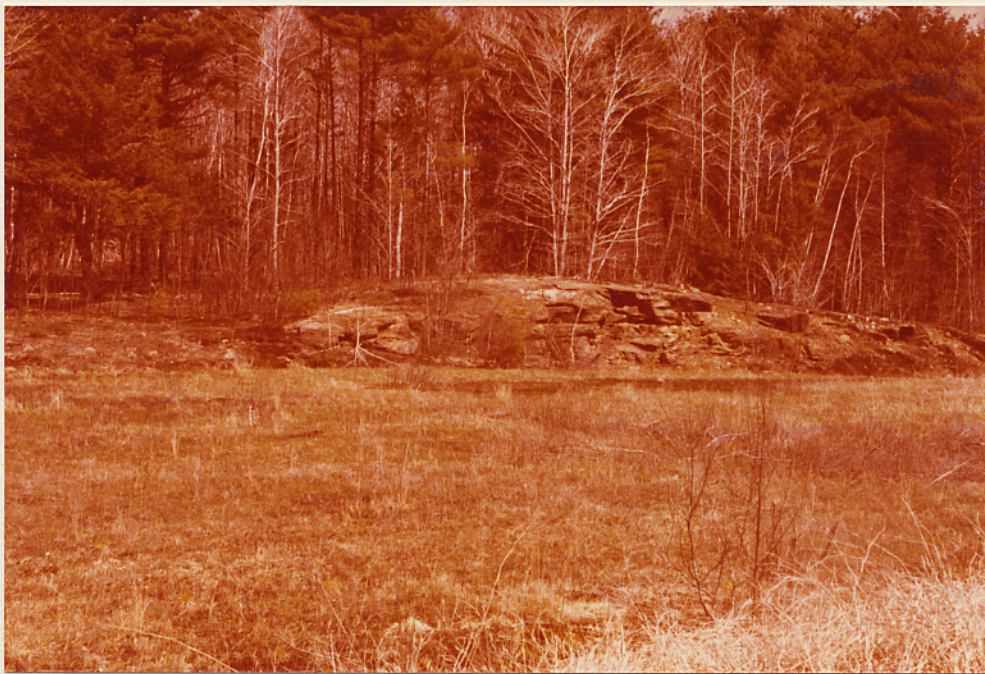
The emergency spillway is in GOOD condition. There are wet spots over much of the spillway but these are due to natural groundwater or ponded runoff. There is some minor growth of saplings and shrubs in the control section.

1. View of emergency spillway channel from the left end of the earth embankment

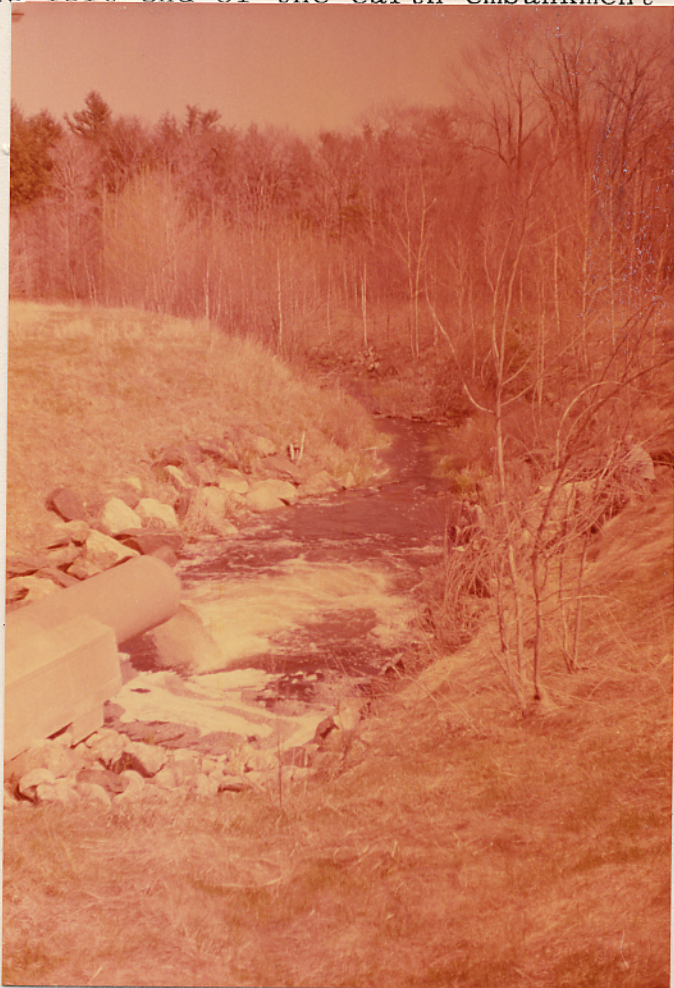
2. View of downstream channel and outlet pipe from the downstream toe.

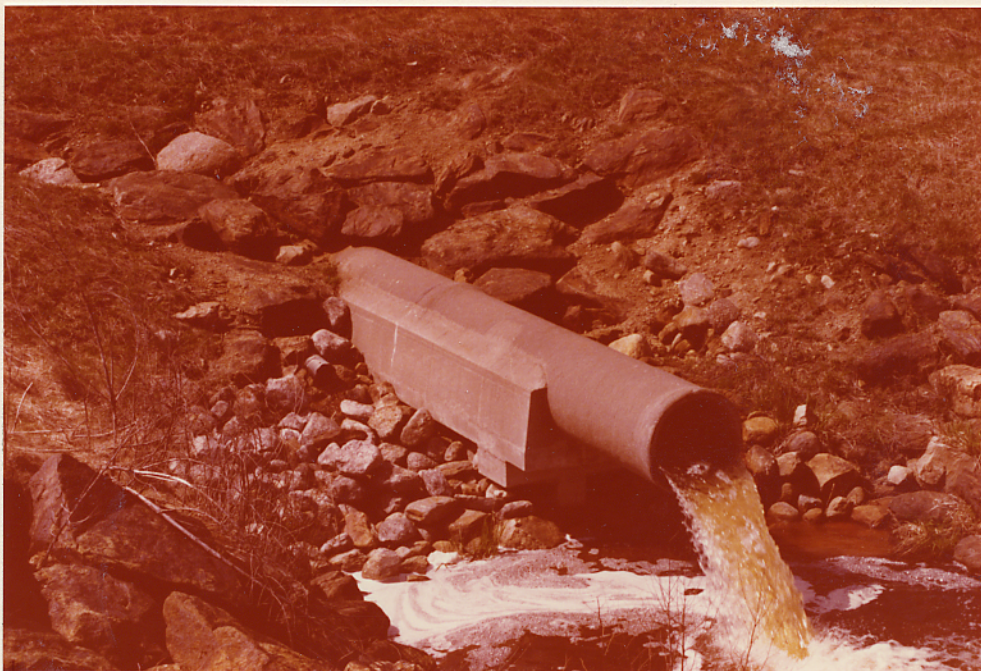
The downstream end of this conduit is in good condition with no evidence of settlement, spalling, cracks, or efflorescence. The source of the present discharge is the low stage orifice opening.

3. View of outlet pipe from downstream

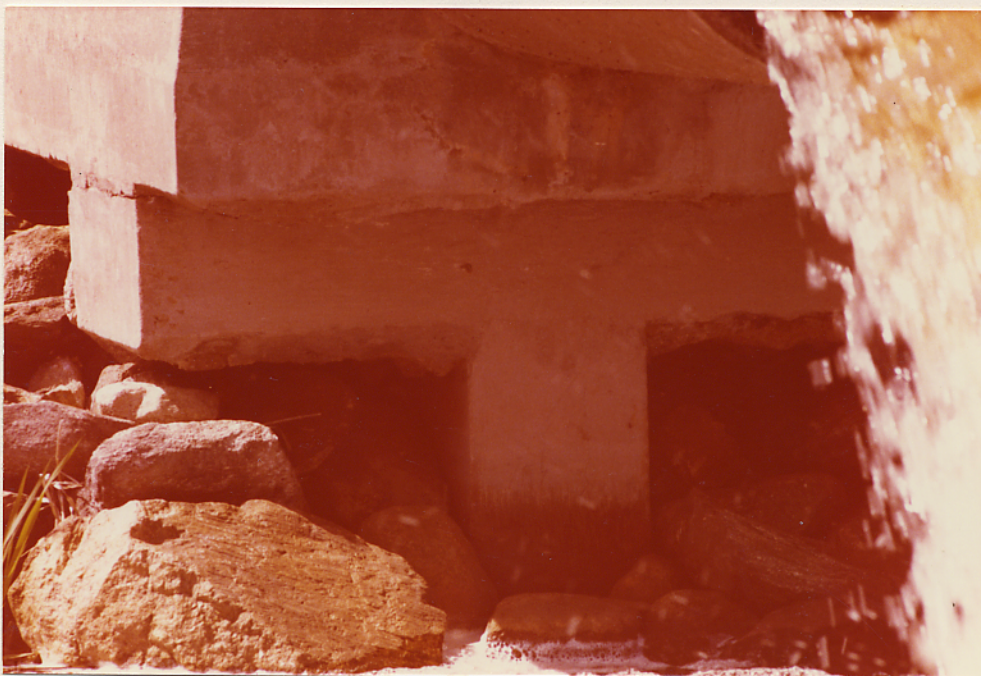
The underside of the tee bent has spalled over the entire length of its downstream end in a 3 inch by 3 inch triangular pattern. The cause of this spalling is unknown. A similar condition exists at the bottom corner of the cantilevered end of the pipe cradle, but to a lesser extent.

AREA EVALUATED	BY	CONDITION & REMARKS
B. Pond Drain Inlet Pipe	PR ↑ ↓ PR	Submerged, could not be observed
C. Outlet Conduit (Primary Spillway) Condition of pipe		No deficiencies noted
D. "T" Bent and Cradle		Bottom of bent spalled over entire length 3" x 3". Bottom of cradle spalled 1" x 1".

4. Detail view of outlet pipe support showing spalling of tree bent and cradle

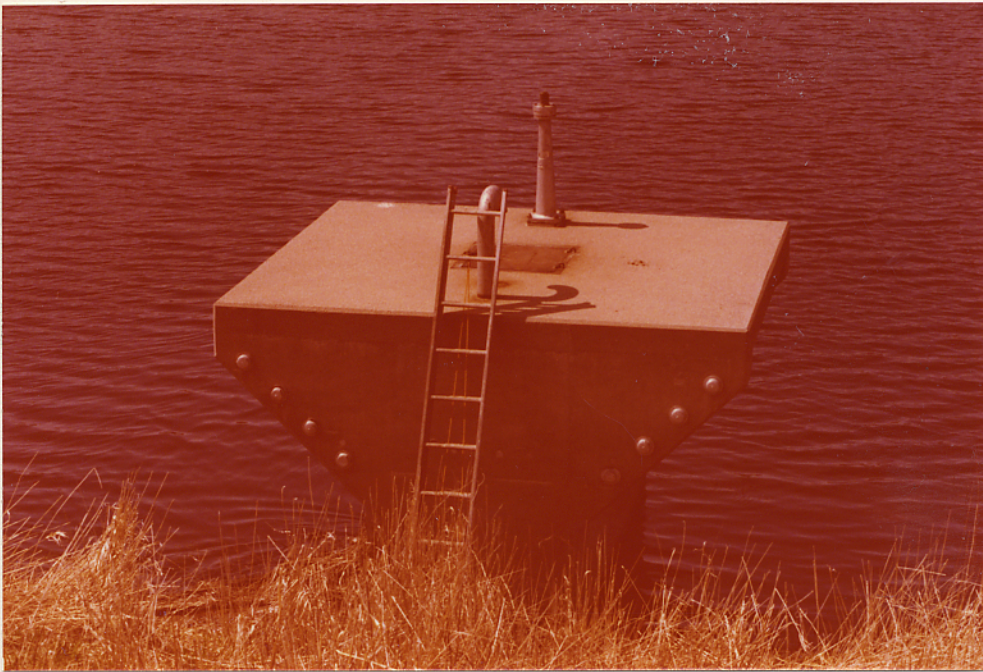
The sluice gate bench stand is in good condition. The hand wheel which operates the gate has been removed from the site to preclude unauthorized use.

5. View of drop inlet structure showing bench stand and vent pipe

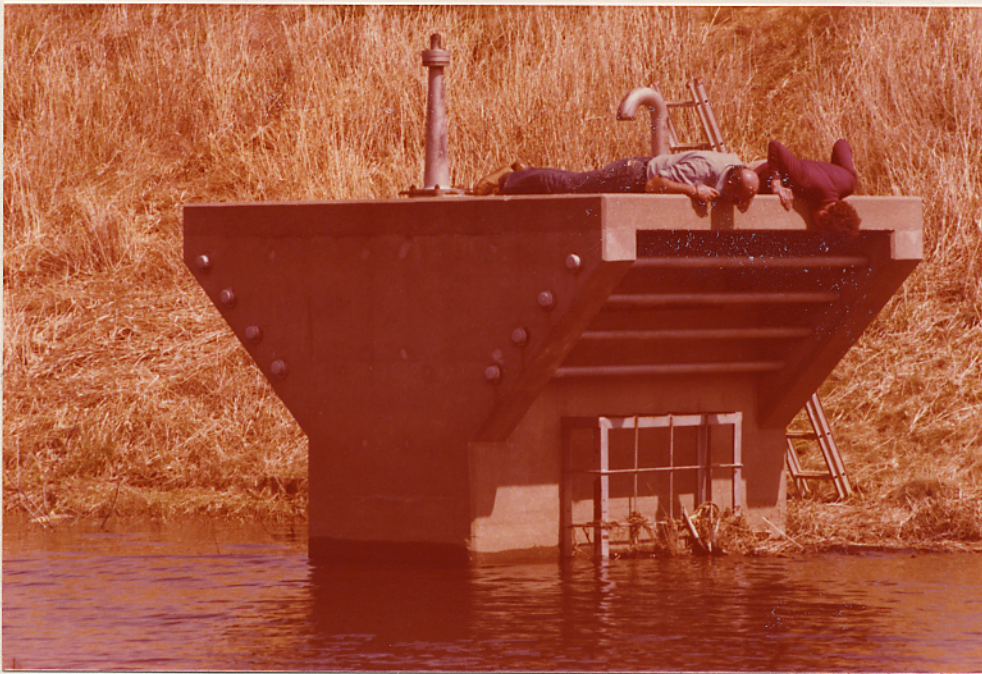
The galvanized trash racks for both inlets are in good condition but clogged with debris.

6. View of drop inlet structure showing trash racks
